Inspection Report

Property Address: 1234 Sample Report Dr Tallahassee FI 32300

Tallahassee Real Estate Inspections, LLC

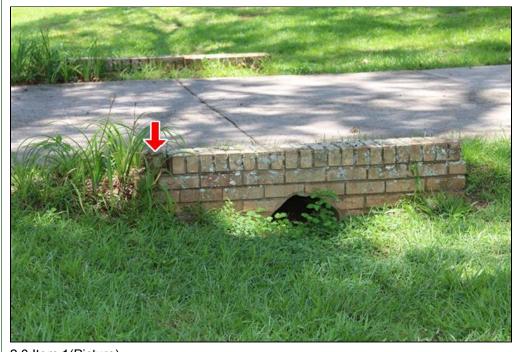
2.0 Item 1(Picture)

2.0 Brick culvert is missing brick on corner.

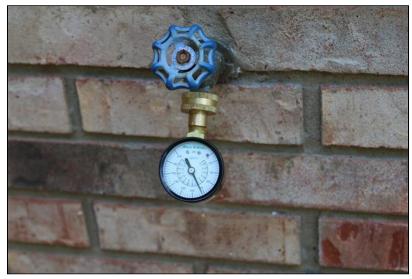
7.7 Item 1(Picture)

7.7 Water Pressure was inside the recommended range of 60-80 psi (approx 70-75 psi).

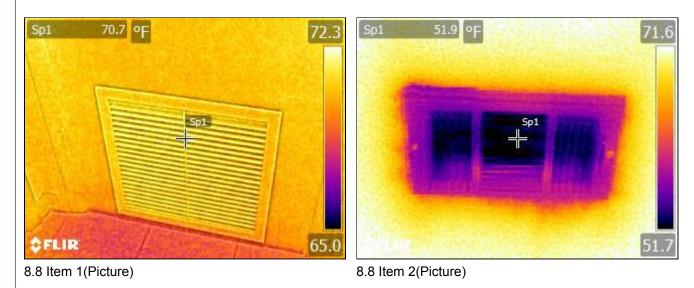
Temperature differential was in acceptable range of 14-22 degrees F (see pictures)

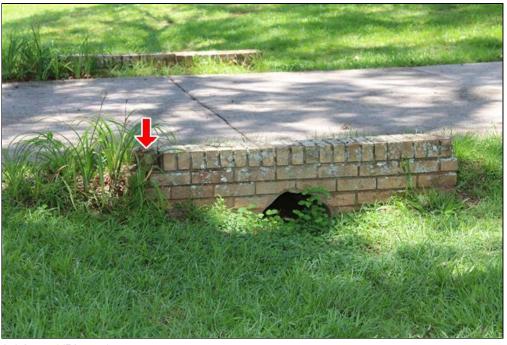
2.0 Item 1(Picture)

Brick culvert is missing brick on corner.
